Forest and Floods

Hla Oo Nwe

Irrigation and Water Utilization Management Department

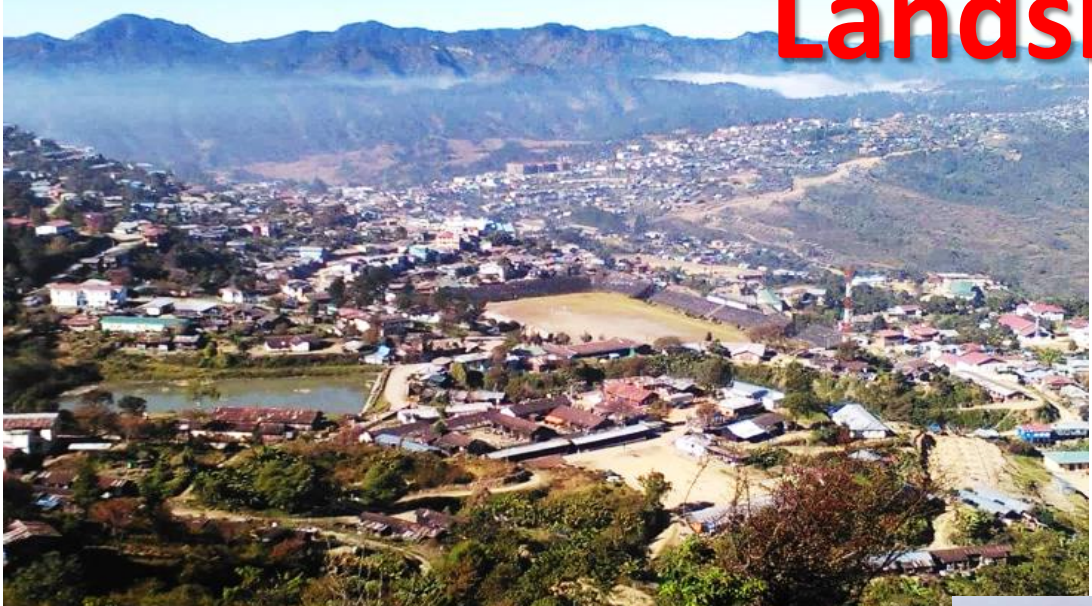
Hakha before Landslide in 2015

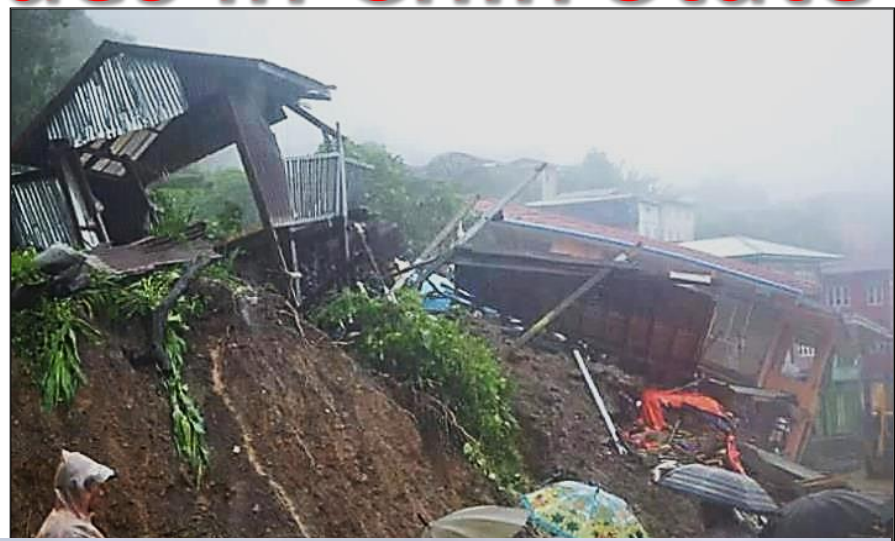
Landslides in Chin State

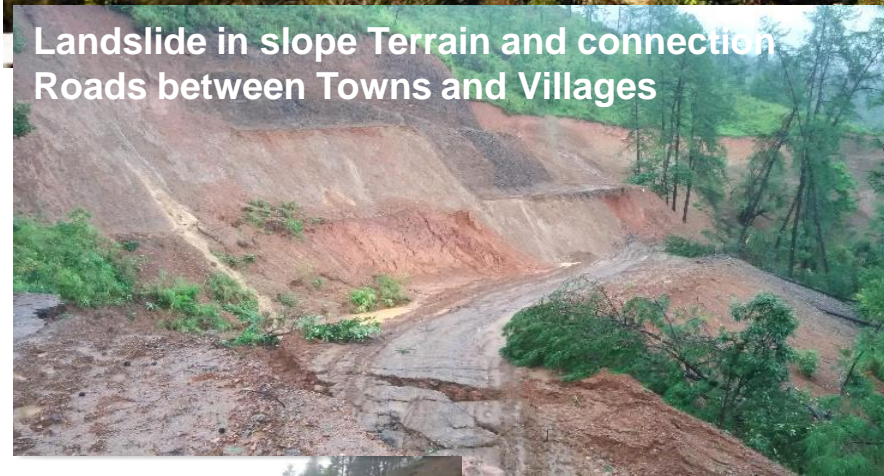
Landslide in slope Terrain and connection Roads between Towns and Villages

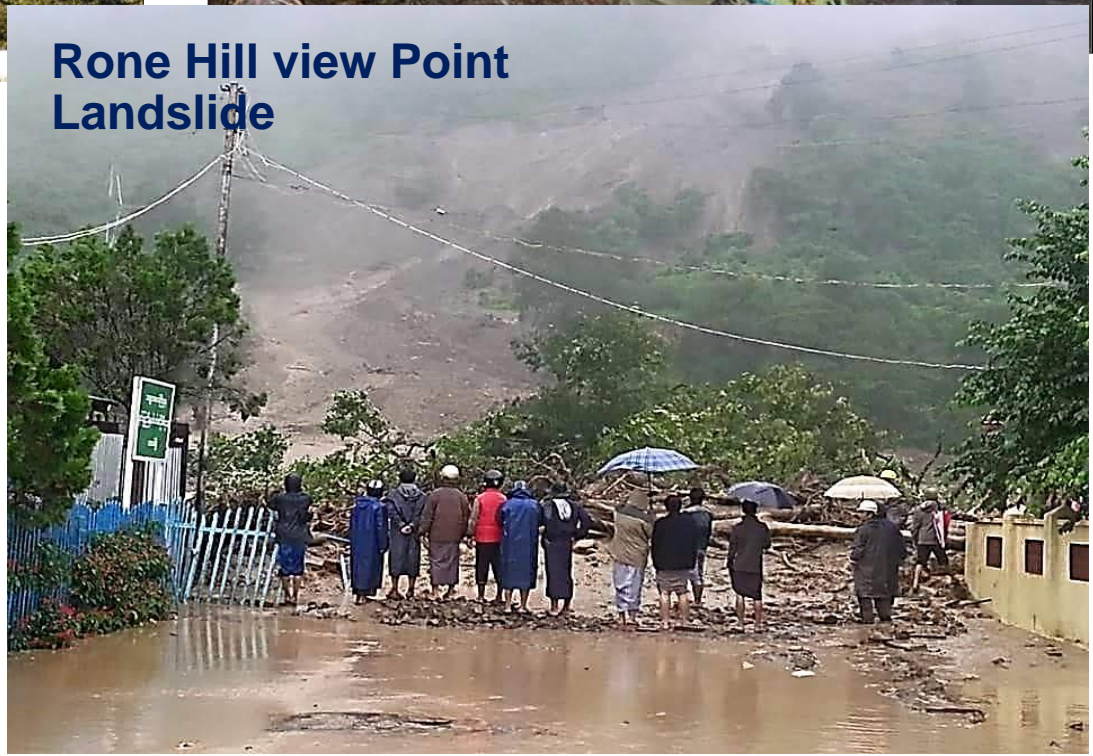
Rone Hill view Point Landslide

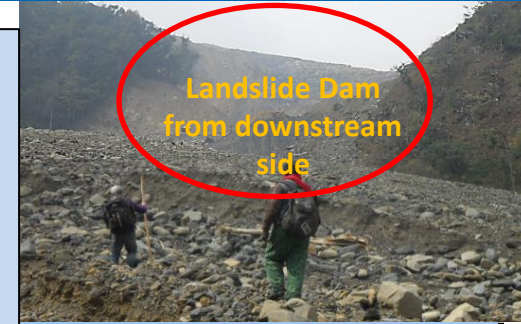
Landslide Dam from downstream side

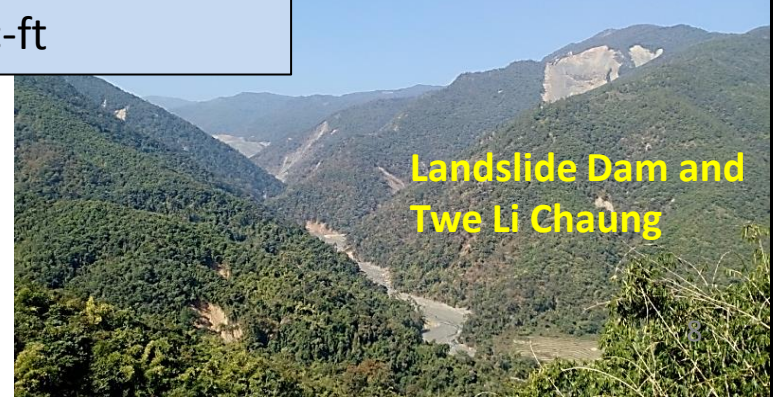
Landslide Dam and Twe Li Chaung

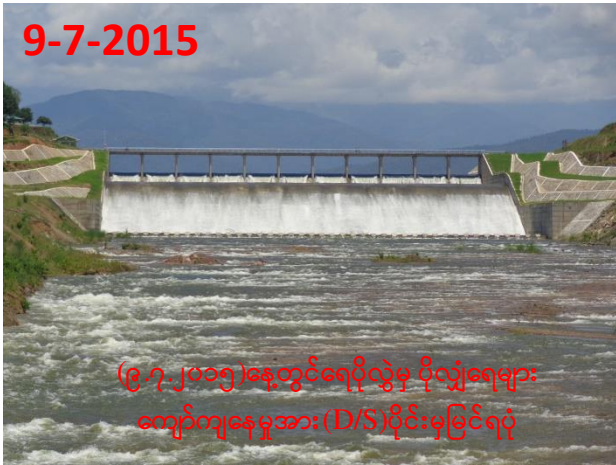
9-7-2015

(၉.၇.၂၀၁၅)နေ့တွင်ရေညိုလွန်းသို့လျှော့ရေများ
ကျော်ကျနေမှုအား (D/S) နိုင်းဖျမြင်ရပုံ

- Dam located in Sagaing Region, Kalay Township, near Yarzagyo village
- Catchment area located in Tunn Zang Township, Chin State
